Manhole Inspection Summary

Manhole # S39WW_044MH

Insp Date: **12/18/06 1:46 PM**

Location Address: **3016 HARTZ LN** Cross Street: **MONTPELIER ST**

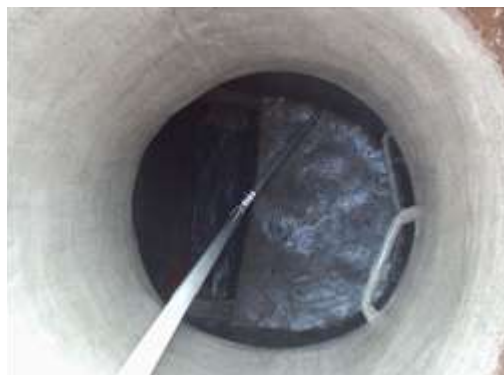
Top View

Corbel Material: **Unknown** ☐ Parged Type: **Concentric/Eccentric**
Condition: ☒ Sound ☐ Cracked ☐ Root Intrusion ☐ Loose Brick ☐ Deteriorated
Infiltration: ☐ None ☒ **Joint** ☐ Cracks ☐ Mortar ☐ Roots ☒ **Wall**

Corbel infiltration.

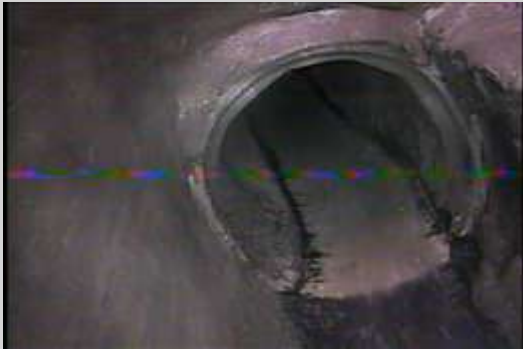
18 in. Circular Gravity Sewer Pipe Out @ 12 O'Clock

Pipe Material: **Unknown** ☒ Pipe Lined

Invert Depth: **9.83** (ft.) Flow Characteristics: **Fast**

Deposits: ☒ None ☐ Mud ☐ Sludge ☐ Debris ☐ Grease

Infiltration: **None** Pipe Seal Cond: **Unknown**

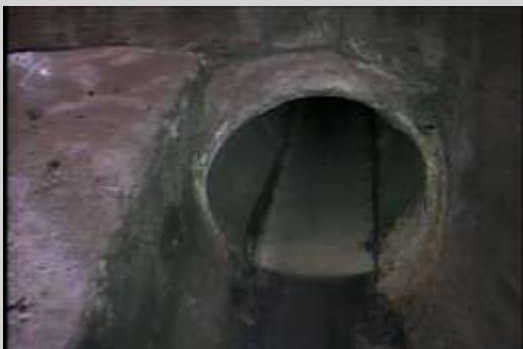
15 in. Circular Gravity Sewer Pipe In @ 6 O'Clock

Pipe Material: **Unknown** ☒ Pipe Lined

Invert Depth: **9.79** (ft.) Flow Characteristics: **Fast**

Deposits: ☒ None ☐ Mud ☐ Sludge ☐ Debris ☐ Grease

Infiltration: **None** Pipe Seal Cond: **Unknown**
